## Hawaan Forest Conservation Trust Monthly site inspection report:

28.04.2022

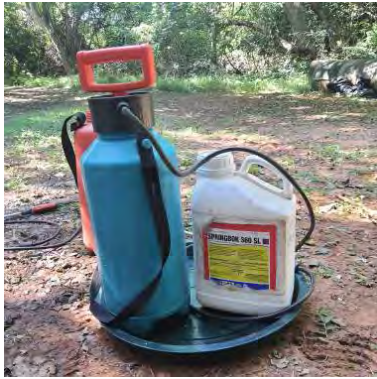
(1)

An audit of the herbicide store was conducted during the site visit. i) The herbicide sprayer needs to be serviced. Herbicide in stock are 20 L Terbadore and 5 L Springbok. We will need a plastic trunk to store the herbicide and sprayers separately from other items the main store. Outstanding PPE for the staff are rubber gloves. AS to print out a material data sheet and display in the store.

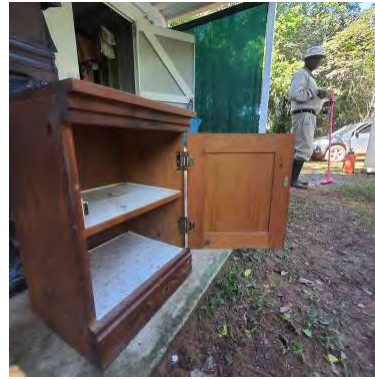
(2)

A small cupboard unit was sourced by AS for the store. This will now function cupboard for food and tea items. The herbicide and fuel will now be stored in the second unit separate from the main store.

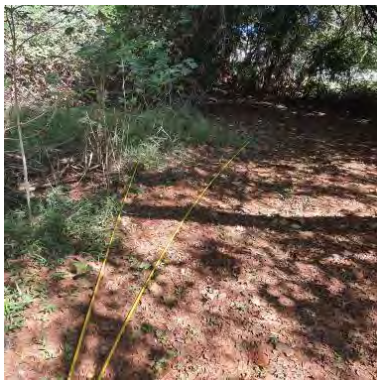
(3)

These plumbing items have now been moved to fenceline and are no longer lying around the management zone area.

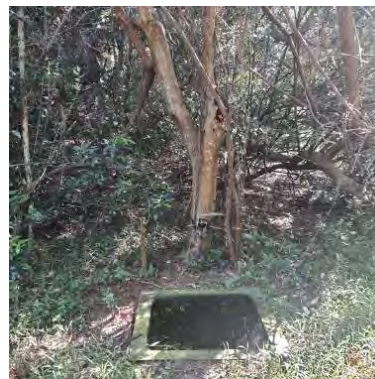
(6)

The camera traps and water points were checked. The rain hampered camera functioning during mid-April so they need to be serviced and new sim cards purchased. Better communication between Marshall and HCT are needed so that these issues can be sorted out quickly.

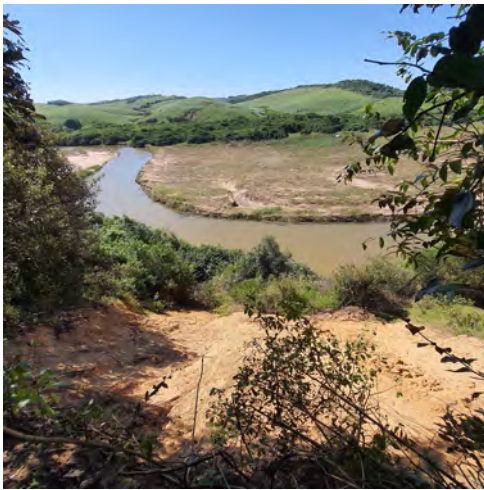
Embankment slip: The extensive rain in mid-April and flooding of the Umhlanga river has triggered a slip of a steep section of the northern forest embankment (Fig. 1a,b). This section of forest appears to have been compromised for some time as exposed sections vegetation (sandy areas in Fig 1c) are visible in the orthophoto which was taken in 2018-2019. The vegetation cover on this slope prior to the slip was largely composed of pioneer vegetation such as *Chromolaena odorata* and *Brachyleana discolor*. It is not immediately clear what management or rehabilitation actions can be conducted to secure such as steep slope. Its likely that the dune slope will find a natural gradient. Aside from engineering options, one approach could be to plant or reseed this bank with fast growing and deep rooting indigenous trees such as *Albizia adianthifolia*. These will take 10 years to become established but if so they will offer resilience to this area for next decadal-scale rainfall event.

Fig. 1a. A perspective of the slip, looking north towards the bend in the Umhlanga river.

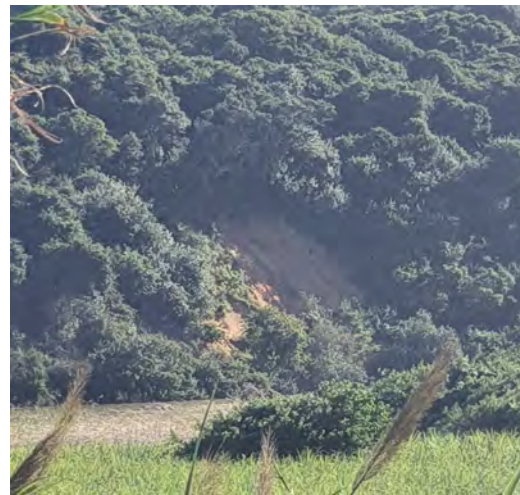
Fig. 1b. A perspective of the slip, looking south across the Umhlanga river towards the forest embankment.

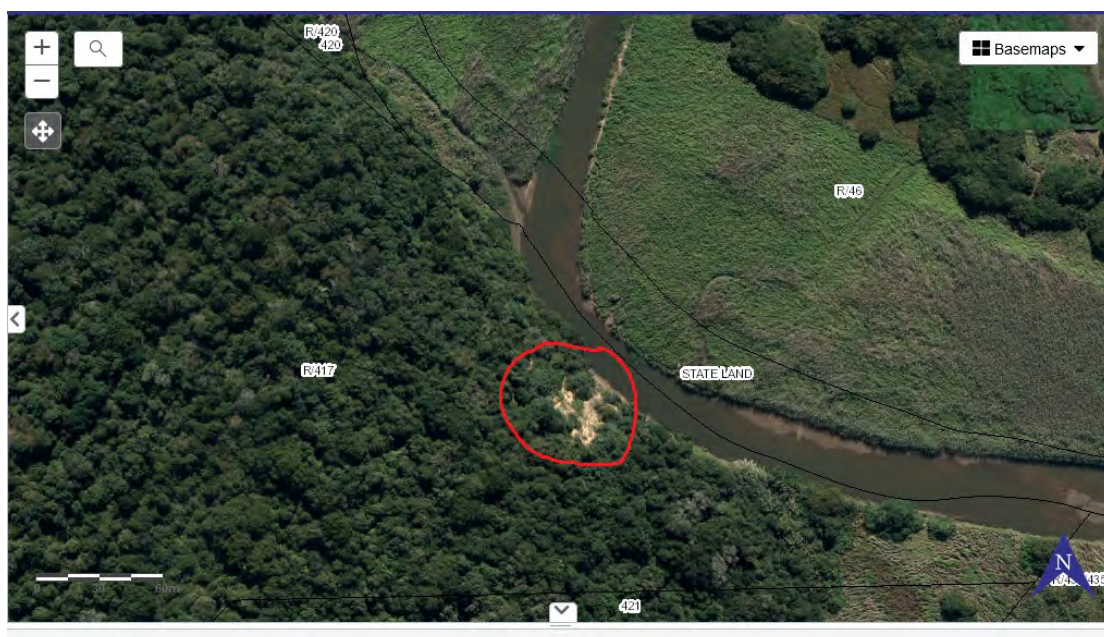
Fig. 1c. An aerial perspective of the area taken in 2018/2019 shows a previous slip which would have likely occurred due to a similar rainfall or disturbance event. The erosion site is located on the outer-apex of the river bend so this may be part of ongoing catchment-scale processes.

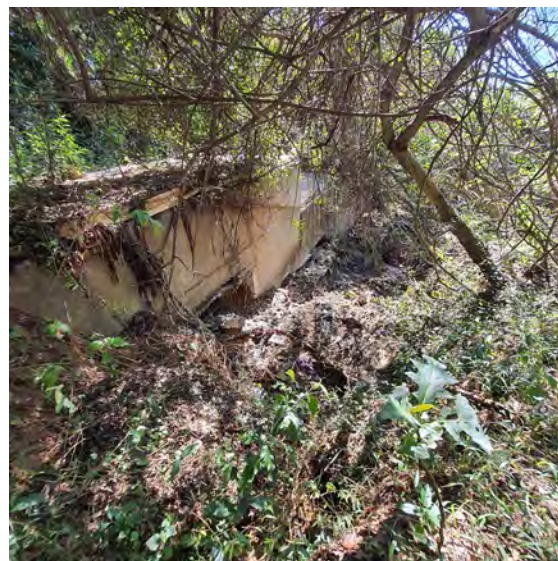
Sewer break: During the rainfall and flooding in mid-April the municipal sewer pipeline on the boundary of the HFT property ruptured. The damage is therefore not in the HFT property but will effect the species in forest. The event resulted in a high pressure flow of sewerage which eroded sections of the pipeline infrastructure while causing a plume of waste into the forest. Fortunately, it appearsers that the runoff did not undercut the pipeline too badly and good work from the city ensured that the issue was resolved timorously. What remains, is for the city to repair the ailing infrastructure and to co-ordinate a clean-up of the litter/plastics which was discharged into the forest.

Fig 1a. The flow of the effluent took a north-easterly direction.

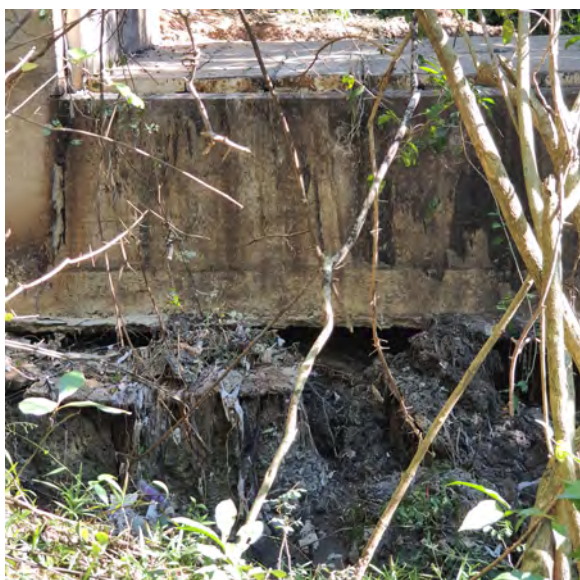
Fig. 2b. Some areas of the pipeline have been undercut and will need to be repaired.

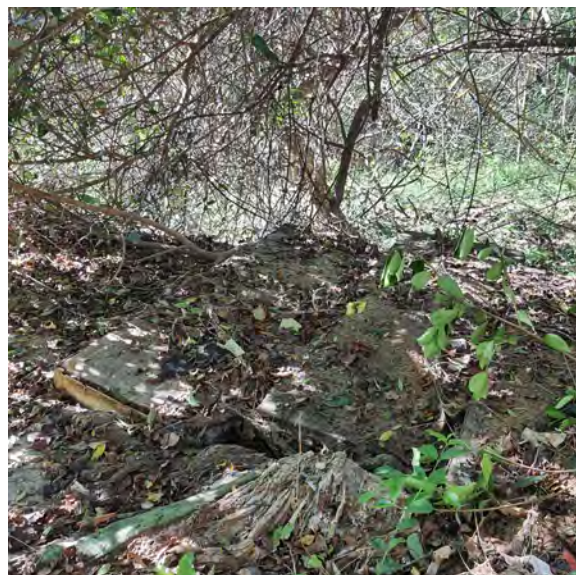
Fig 2c. The manholes on the pipeline remain open for the time being.

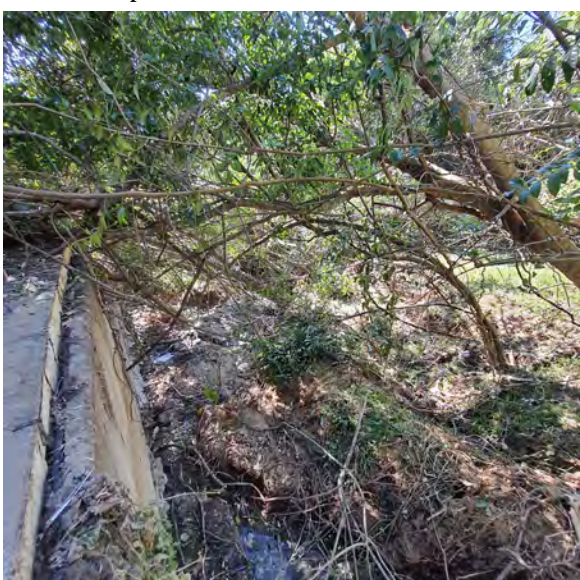
Fig2d. Some of the surrounding vegetation at the source point has collapsed but damage does not seem to be extensive. However, a full inspection has not been conducted.

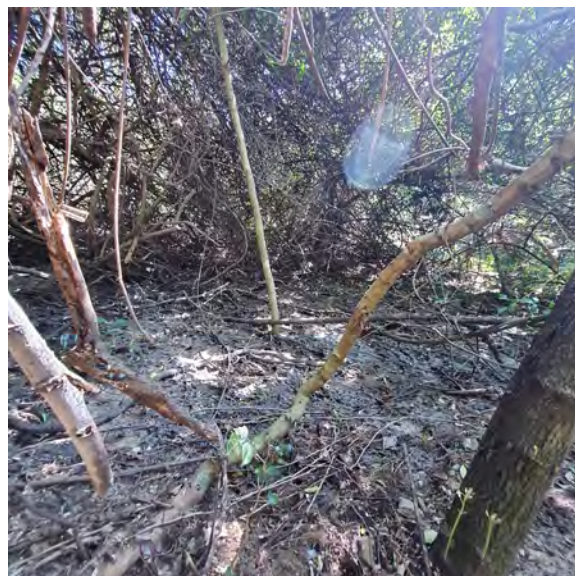
Fig. 2e. The sewage plume continues in a north-east direction down the forest slope. Litter from this plume should be cleaned-up.
